THE OFFICIAL VOICE OF GP-4 BUILDERS ALL OVER THE WORLD

VOLUME 14

MAY - JUNE 1997

BILL BERRICK OF OMAHA, NEBRASKA MAKES HIS FIRST FLIGHT IN HIS GP-4!

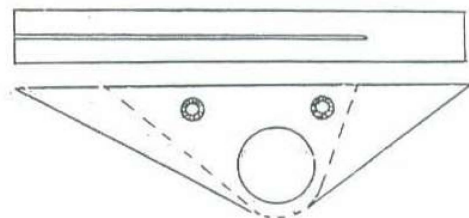
NYLON TAIL SKID

I also added another 2 oz. by making a tail skid out of 3/4" nylon to fit over the sheet metal tie down point on the tail truss, (see drawing). It fits against the tail cone and is retained by two 10-32 machine screws. The tie down point is less than two feet off of the runway at
