GP-4 BUILDERS & FLYERS NEWSLETTER

June-Sept 2004
GP4BFN 44

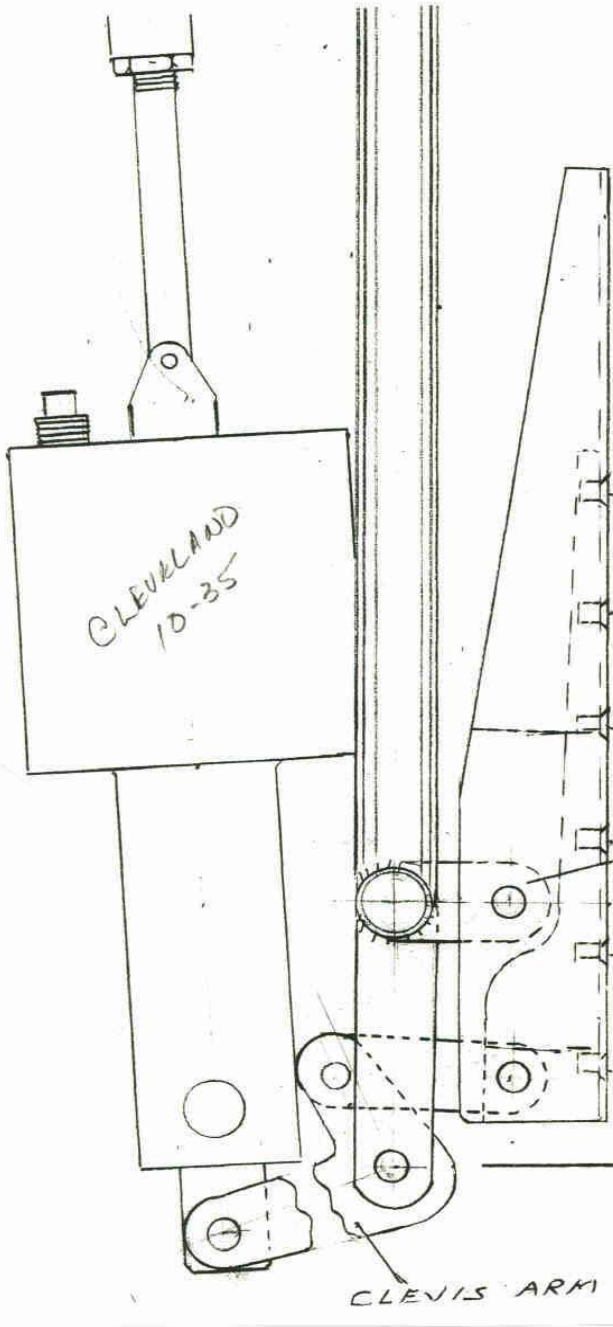
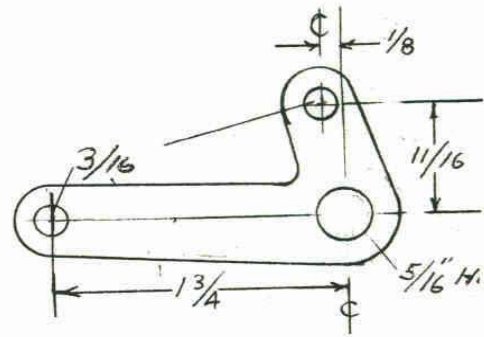
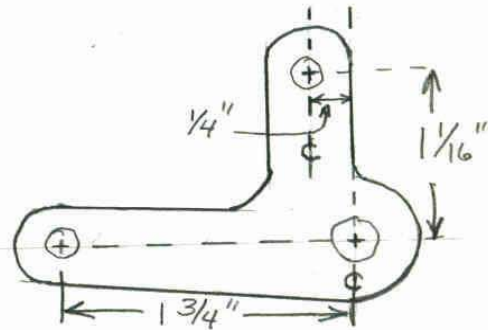
FIGURE 1

During my initial test flights of my GP4, I discovered that I had difficulty holding sufficient brake pressure to execute a run-up at 1700 rpm. Additionally, I was also disappointed with the braking performance in general.

Ernie Holmes (fellow GP4 owner from MA) had the same problem and replaced his wheels and brakes with Cleveland high energy devices (Wicks PN CWB 199-197) and solved his problem. I ordered the high performance units but upon receipt it appeared that I would have to rework my main landing gear doors to accommodate the larger caliper assembly. I returned the new devices and then I redesigned the brake actuating lever at the base of the brake pedals. I made an initial change to the clevis arm and was able to hold the aircraft up to 2000 rpm.

I have now redesigned the linkage a third (and final) time and can now hold the airplane up to 2300 rpm. The attached drawing (Figure 1) shows the revised dimensions of my last version.

MODIFIED CLEVIS ARM DIMENSIONS

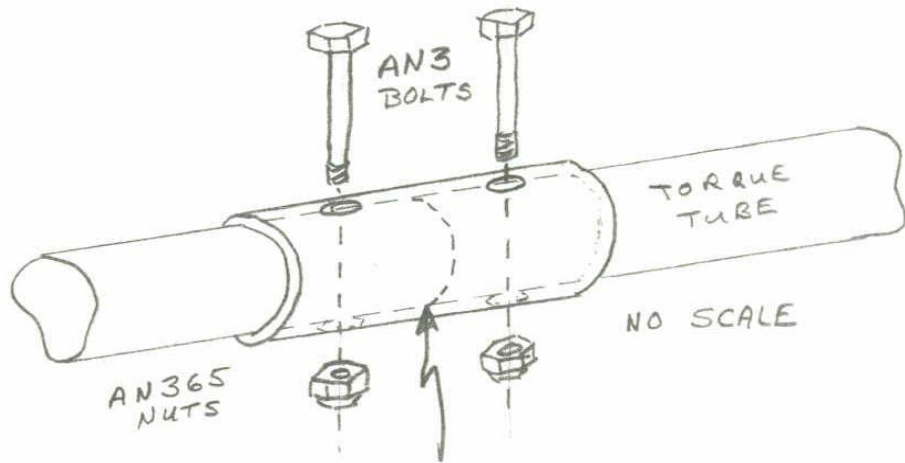
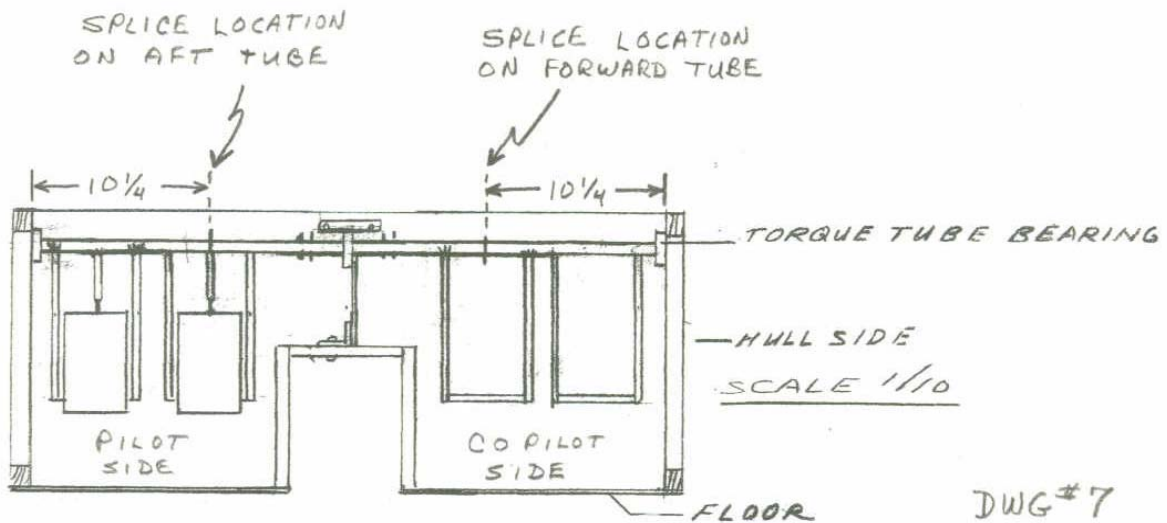
FIGURE 2

During an earlier visit to Massachusetts, Ernie Holmes had suggested that I install a splice and coupling sleeve on the brake pedal torque tubes to facilitate the easier removal of these shafts through the small opening in the top of the fuselage. This has proven to be a blessing and I strongly suggest that builders consider installing the split shafts.

I made the splice cuts 10 1/4" from the end of the torque tube. The two sleeves are 1" diameter 4130; 2 1/2 inch lengths. The sleeve is capable of sliding on the shaft. AN3 bolts are installed through each shaft. The aft tube splice is on the pilot side, the forward tube splice is on the copilot side (Figure 2).

George Pereira suggests filling the spliced tube section near each hole with Flox to strengthen the torque tube so it isn't compressed when tightening the AN3 bolts. I strongly recommend this modification for ease of removal of these assemblies. Thanks to Ernie for the great idea.

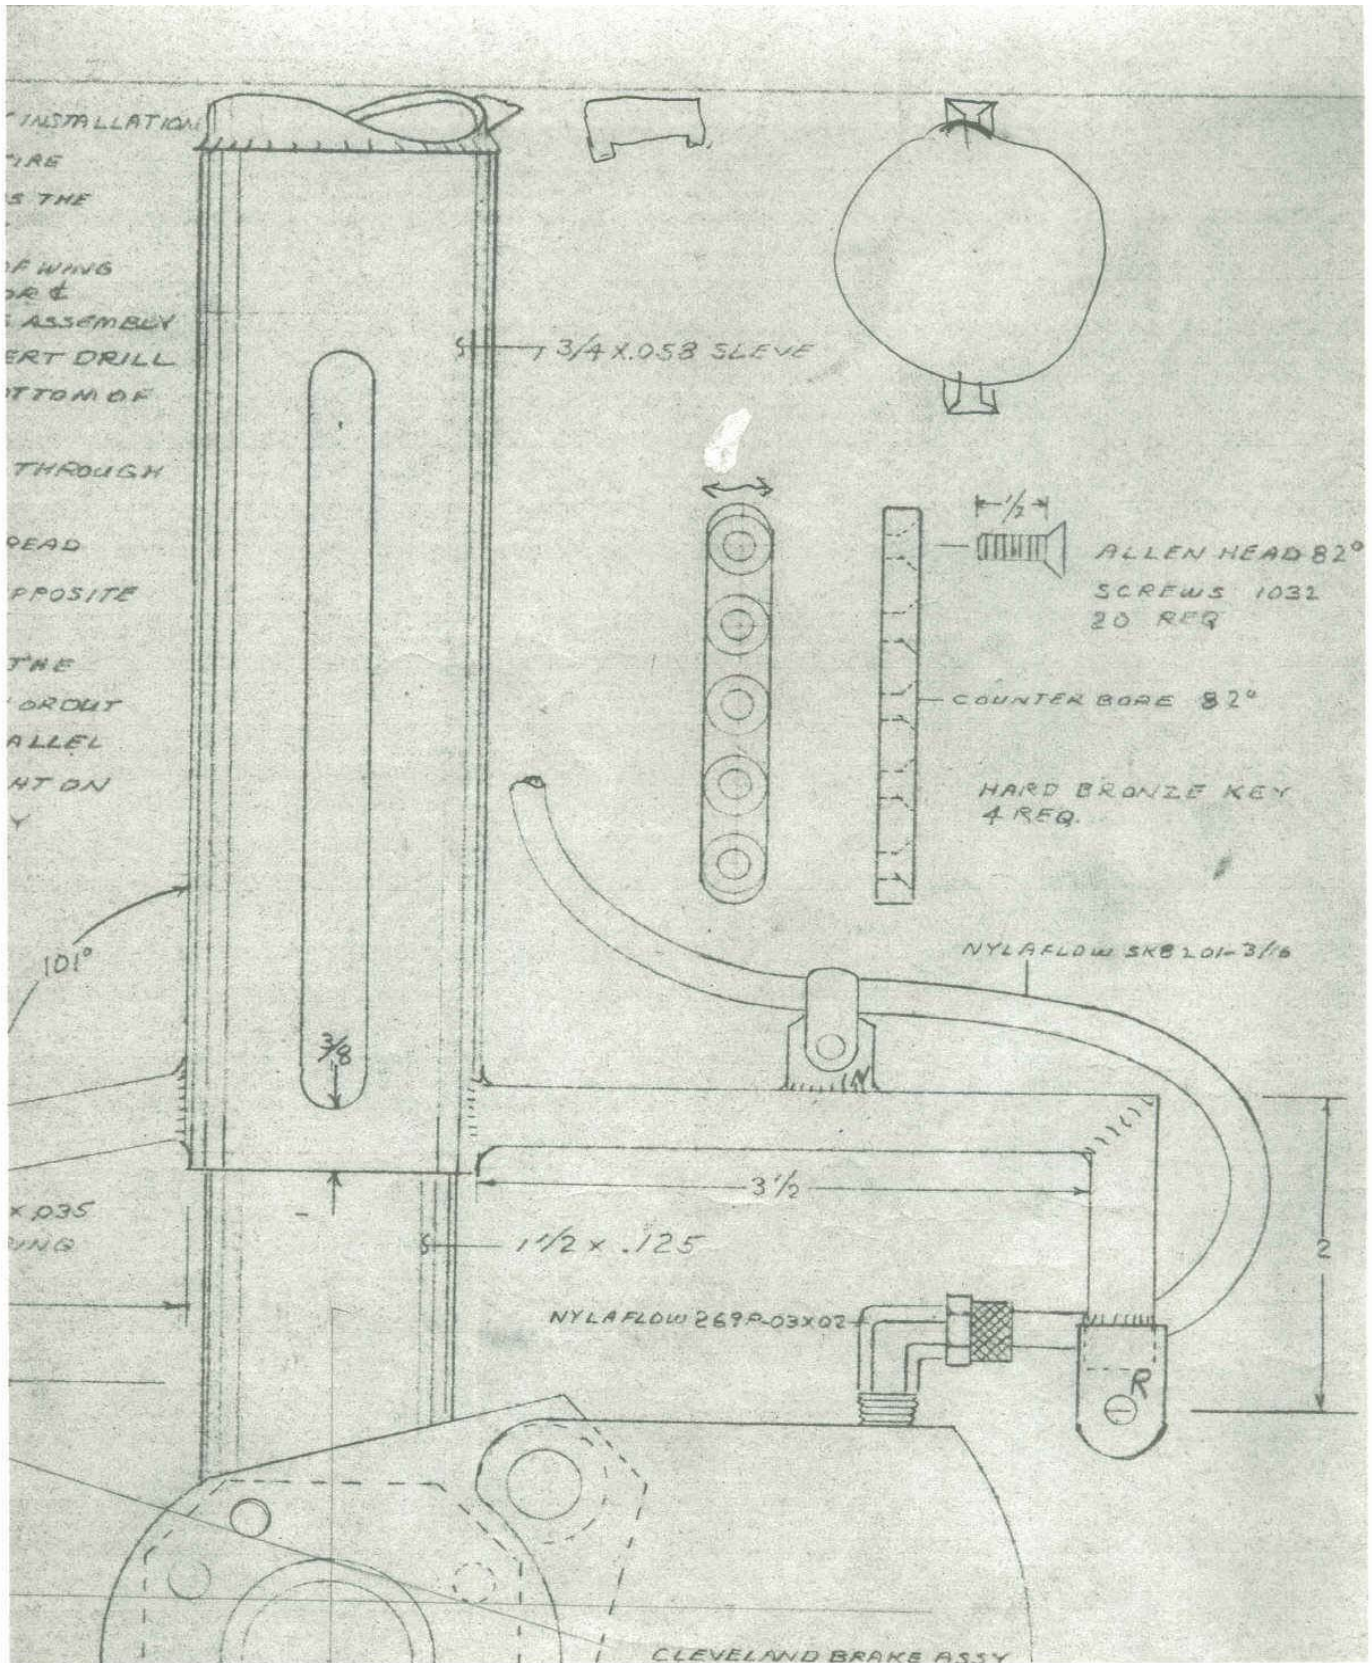
FIGURE 1

After approximately 50 hours of flight on my GP-4, while I had my GP-4 up on jacks and was inspecting my main landing gear, I discovered that I had an excessive amount of 'side to side' play in the 'hard bronze keys' which ride in the 4 3/4" vertical slots. See figure #1 for original plans view. I assumed this was due to initial wearing of the slots.

I decided to create a new set of wider keys to match the slot width. This was done and successfully removed the excessive play.

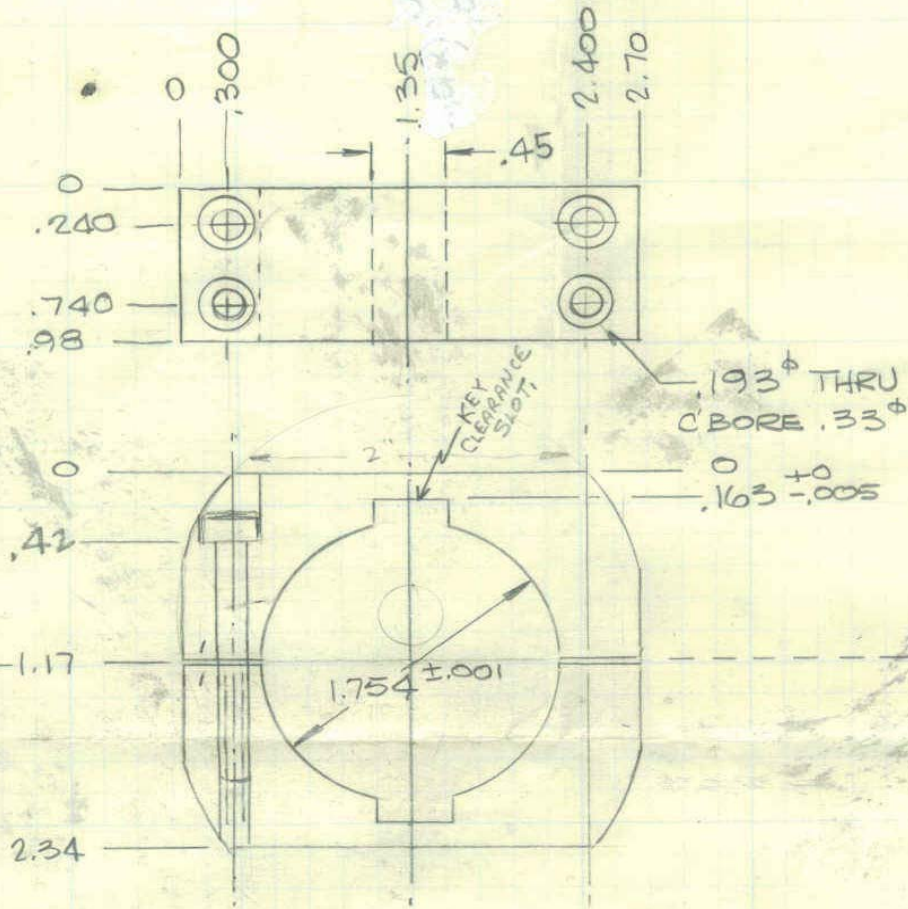
LANDING GEAR COLLAR DRAWING
FIGURE 2

Following approximately 40 additional hours of flight, once again I found that I had an excessive amount of 'side to side' play with the new keys in the slot. Further investigation revealed that the slot was not actually wearing, but the tube in which the slot is machined, is actually bowing out, creating an oval or out of round condition.

To prevent this from occurring further, and to restore the tube to its original shape, I've created a two piece aluminum collar which fits over the outside of the tube assembly and 'squeezes' the tube back to its original round shape. This collar was so effective that the oversized keys needed to be removed and the original keys be reinstalled.

The collars are fabricated from one inch thick, solid aluminum stock.

Figure #2 illustrates the dimensions used for the new collar assemblies. The two halves are bolted together using (4) cap screws in each assembly. The top section has been recessed for the cap screw heads. The bottom section is tapped to receive the caps screws. These collar assemblies are then positioned on the left and right main landing gear strut, making sure that they do not interfere with the brake line or wheel key travel. Figure #3 shows the actual collar installed on my landing gear leg.

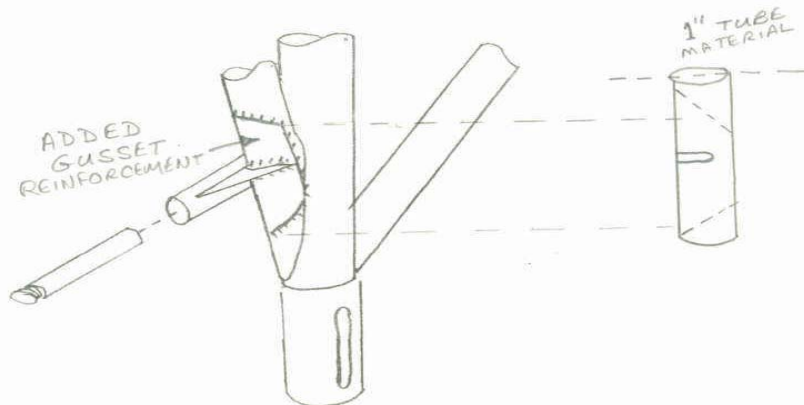
FIGURE 3

I had built and installed the hydraulic landing gear per George Pereira's plans. During a March 2003 discussion with Pat Salomone, GP-4 builder and flyer in Florida, he had suggested the addition of a gusset to support the tube at the center forward section of the main gear truss. This tube houses the 3/8" diameter stud used as the pivot for the actuating link (hydraulic gear drawing, M-6). I added the gusset as illustrated in figure #1. After approximately 65 hours of flight time, during a preflight inspection of the left landing gear assembly, I discovered a crack in the forward tube near the point of the gusset attachment as illustrated in figure #2. I then removed the landing gear trusses (left and right) and created an additional gusset to reinforce the entire area of each strut. The cracked area was welded together, and then the new support was cut from a section of 1" diameter tubing and welded in place over the gusset/tube connection as illustrated in figure #3.

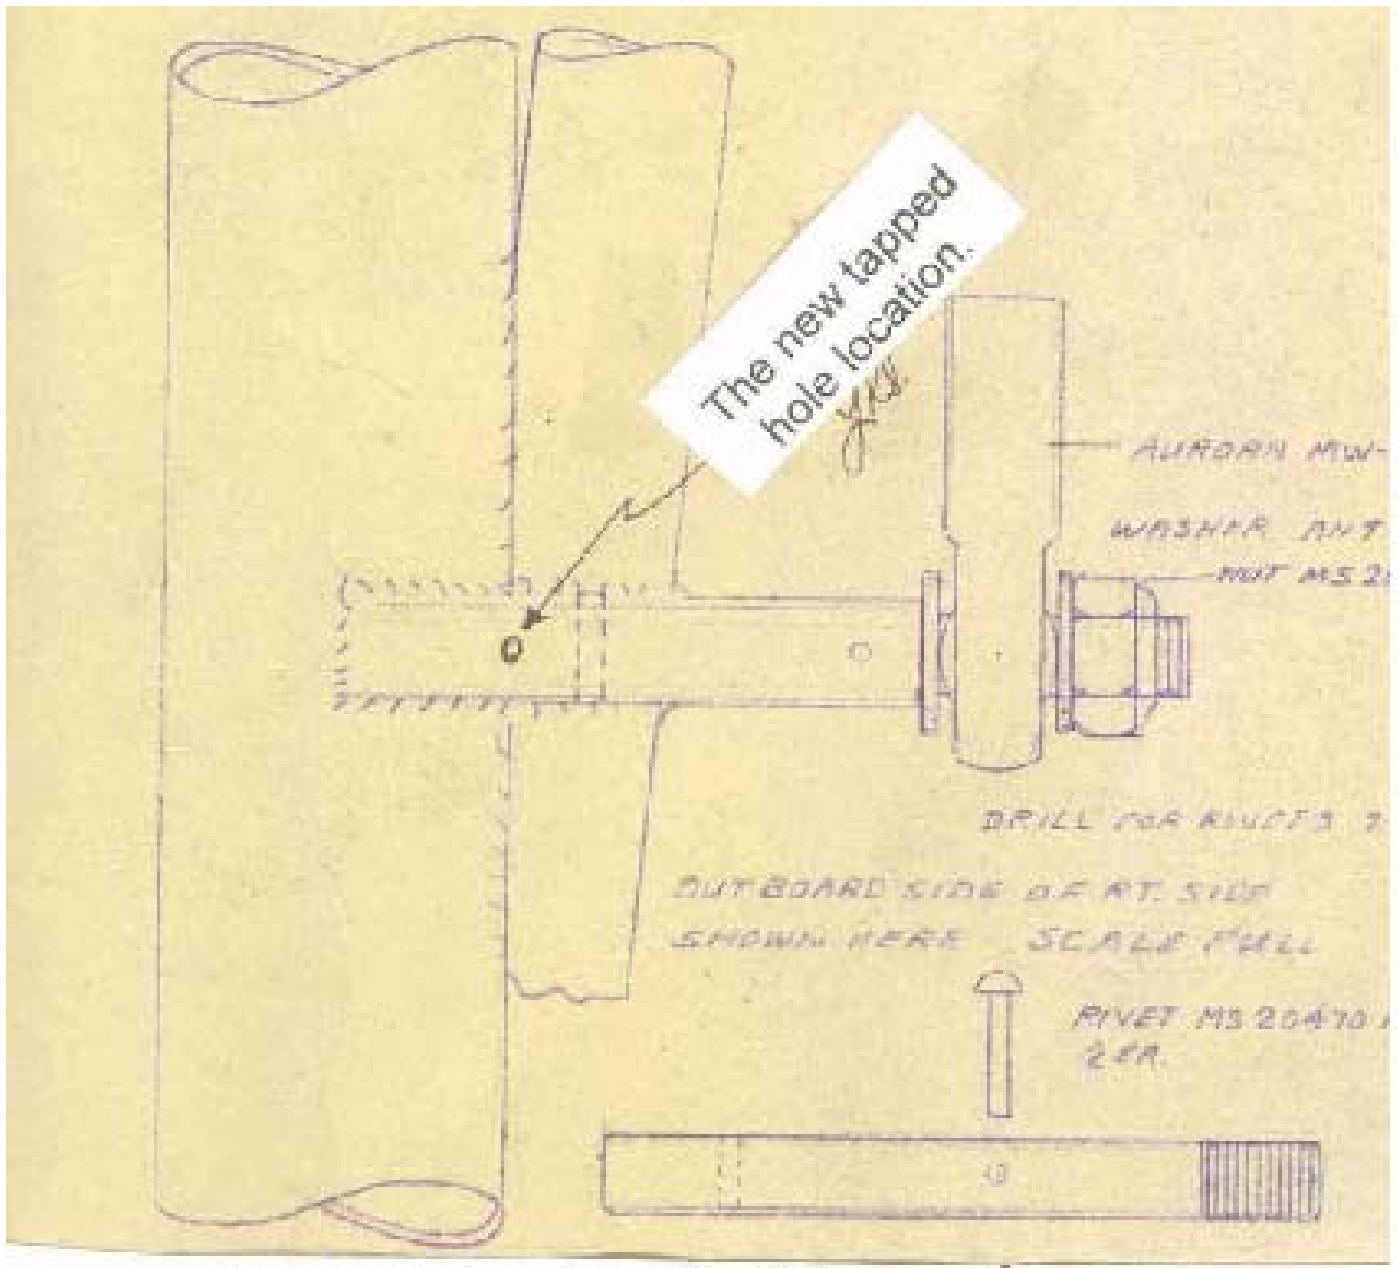
FIGURE 4

I had now been flying my GP-4 for about 90 hours when I had a failure of the left main landing gear leg which resulted in damage to the left gear door, the left horizontal stabilizer, the left elevator and the tail cone (stinger) and tail light assembly. The good news is that the gear stayed up enough to keep the left wing tip from touching down. I must admit that the failure occurred on a less than perfect landing whereby I dropped the GP-4 in, from my estimate, of less than two feet. I was landing at an unfamiliar 2,000' strip and got too slow during the flare. However, I believe that our landing gear should withstand such a landing.

I'll do my best to describe the nature of the failure and the measures which I took to prevent the same type of failure in the future. Hydraulic gear drawing, M-6 illustrates the 3/8" bolt installation (see figure #4). Per the plans, the bolt is inserted into the 1/2" X .065 tube and retained by a rivet approximately 1/4" into the tube. The bolt failed at the rivet hole.

The bolt failed at the rivet hole. →

Following the failure, I removed the remaining bolt section by tapping into the bolt and pulling it out of the sleeve. I reshaped the tube (which naturally became deformed as a result of the failure) and re-welded it together. I then took the next larger diameter 4130 tubing, and welded it over the full length of the original tube. The result is I have

now doubled the wall thickness of this sleeve.

When I installed the new bolt, I chose not to use a rivet to retain the bolt into the sleeve. Instead, I drilled and tapped the bolt, as far back as practical, and used an 8-32 cap screw to retain the bolt within the sleeve (see photograph, figure # 5). The result is that the bolt is completely solid in the forward section. I believe that the rivet hole weakened the bolt and created the opportunity for a failure at this location. And yes, naturally, I did the above described modification to the right main landing gear as well.

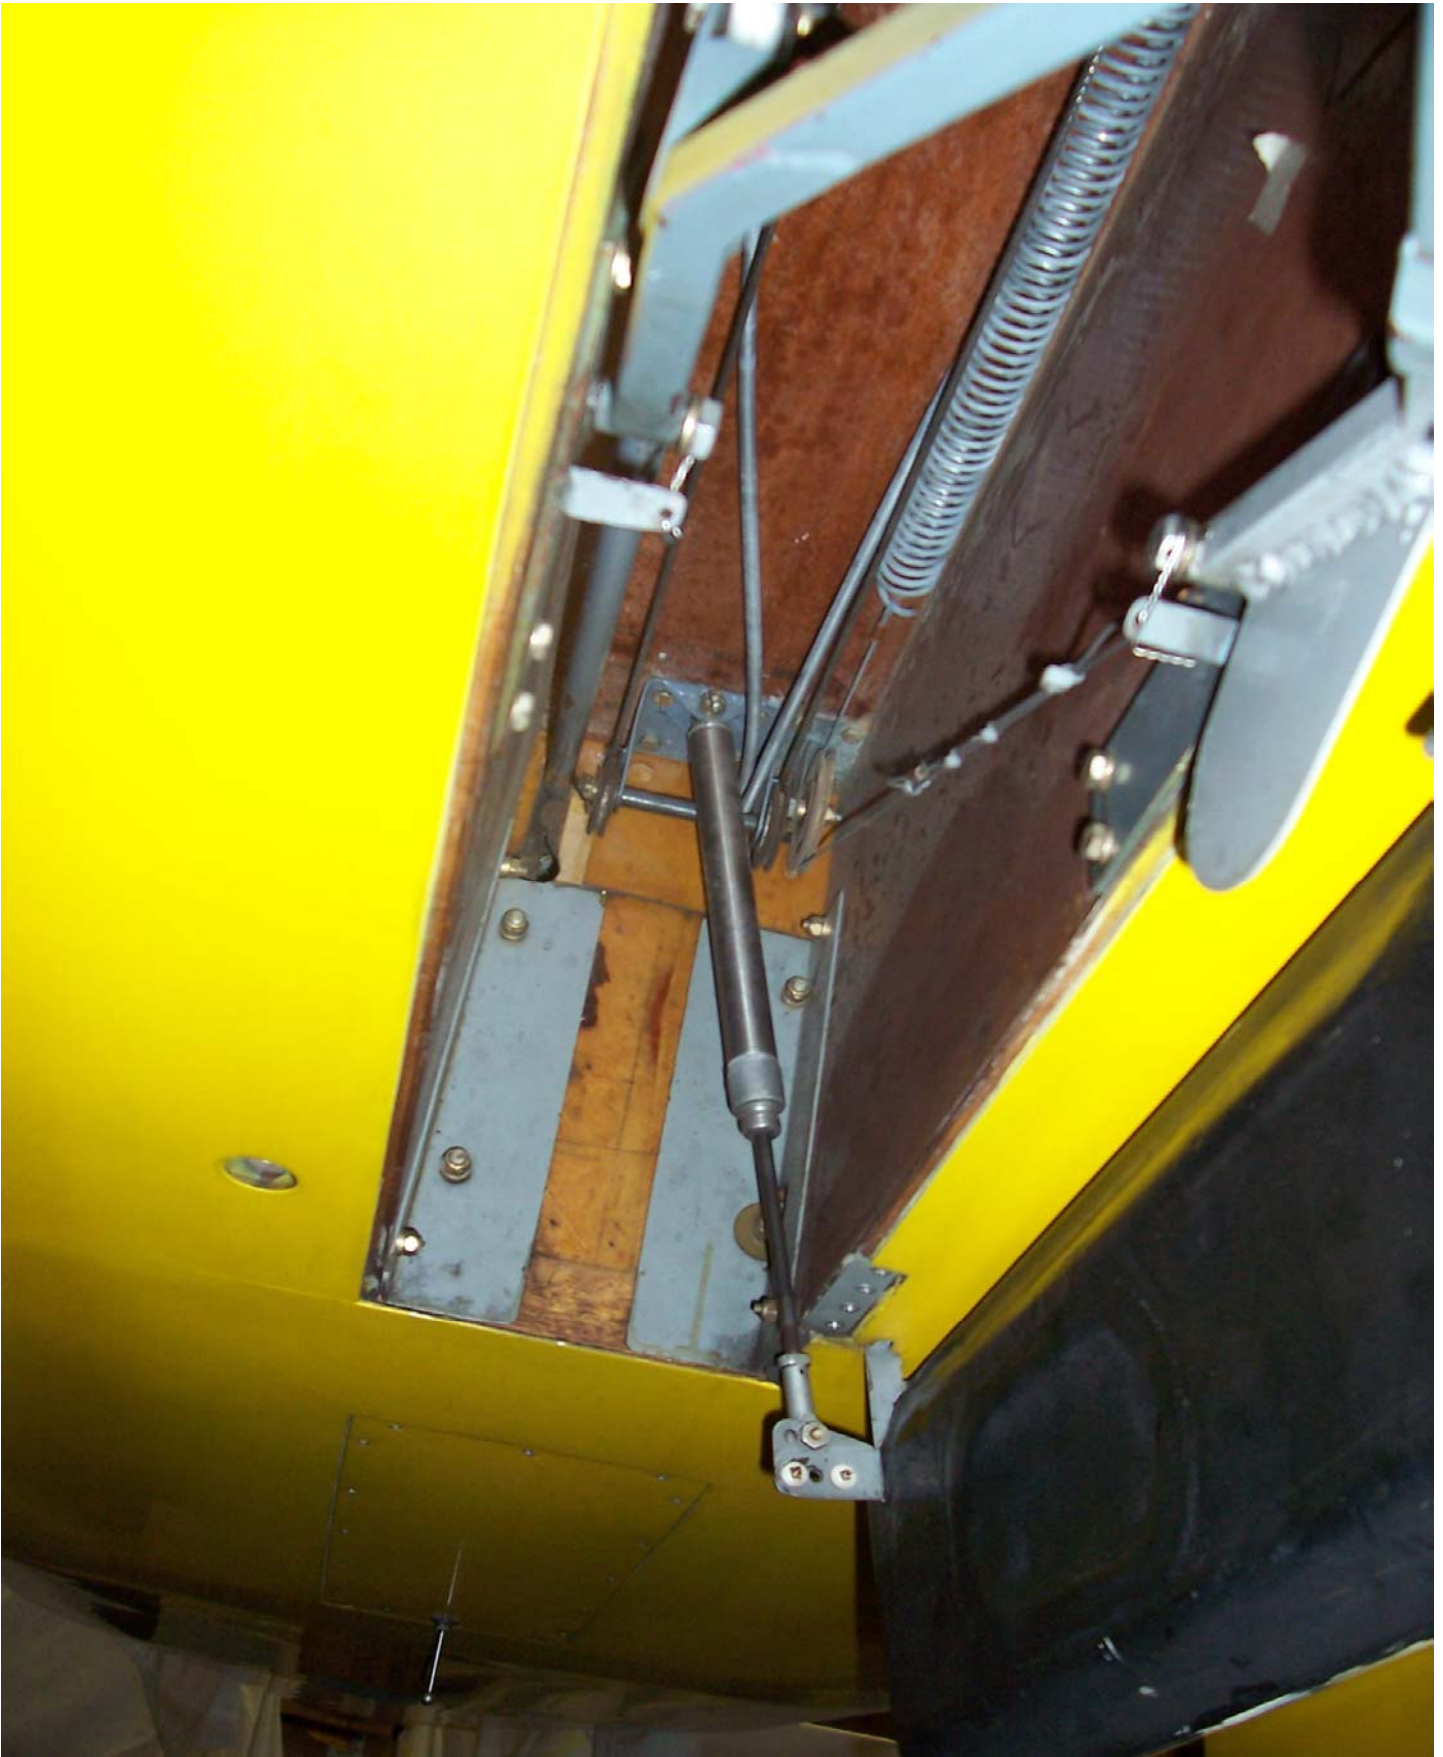
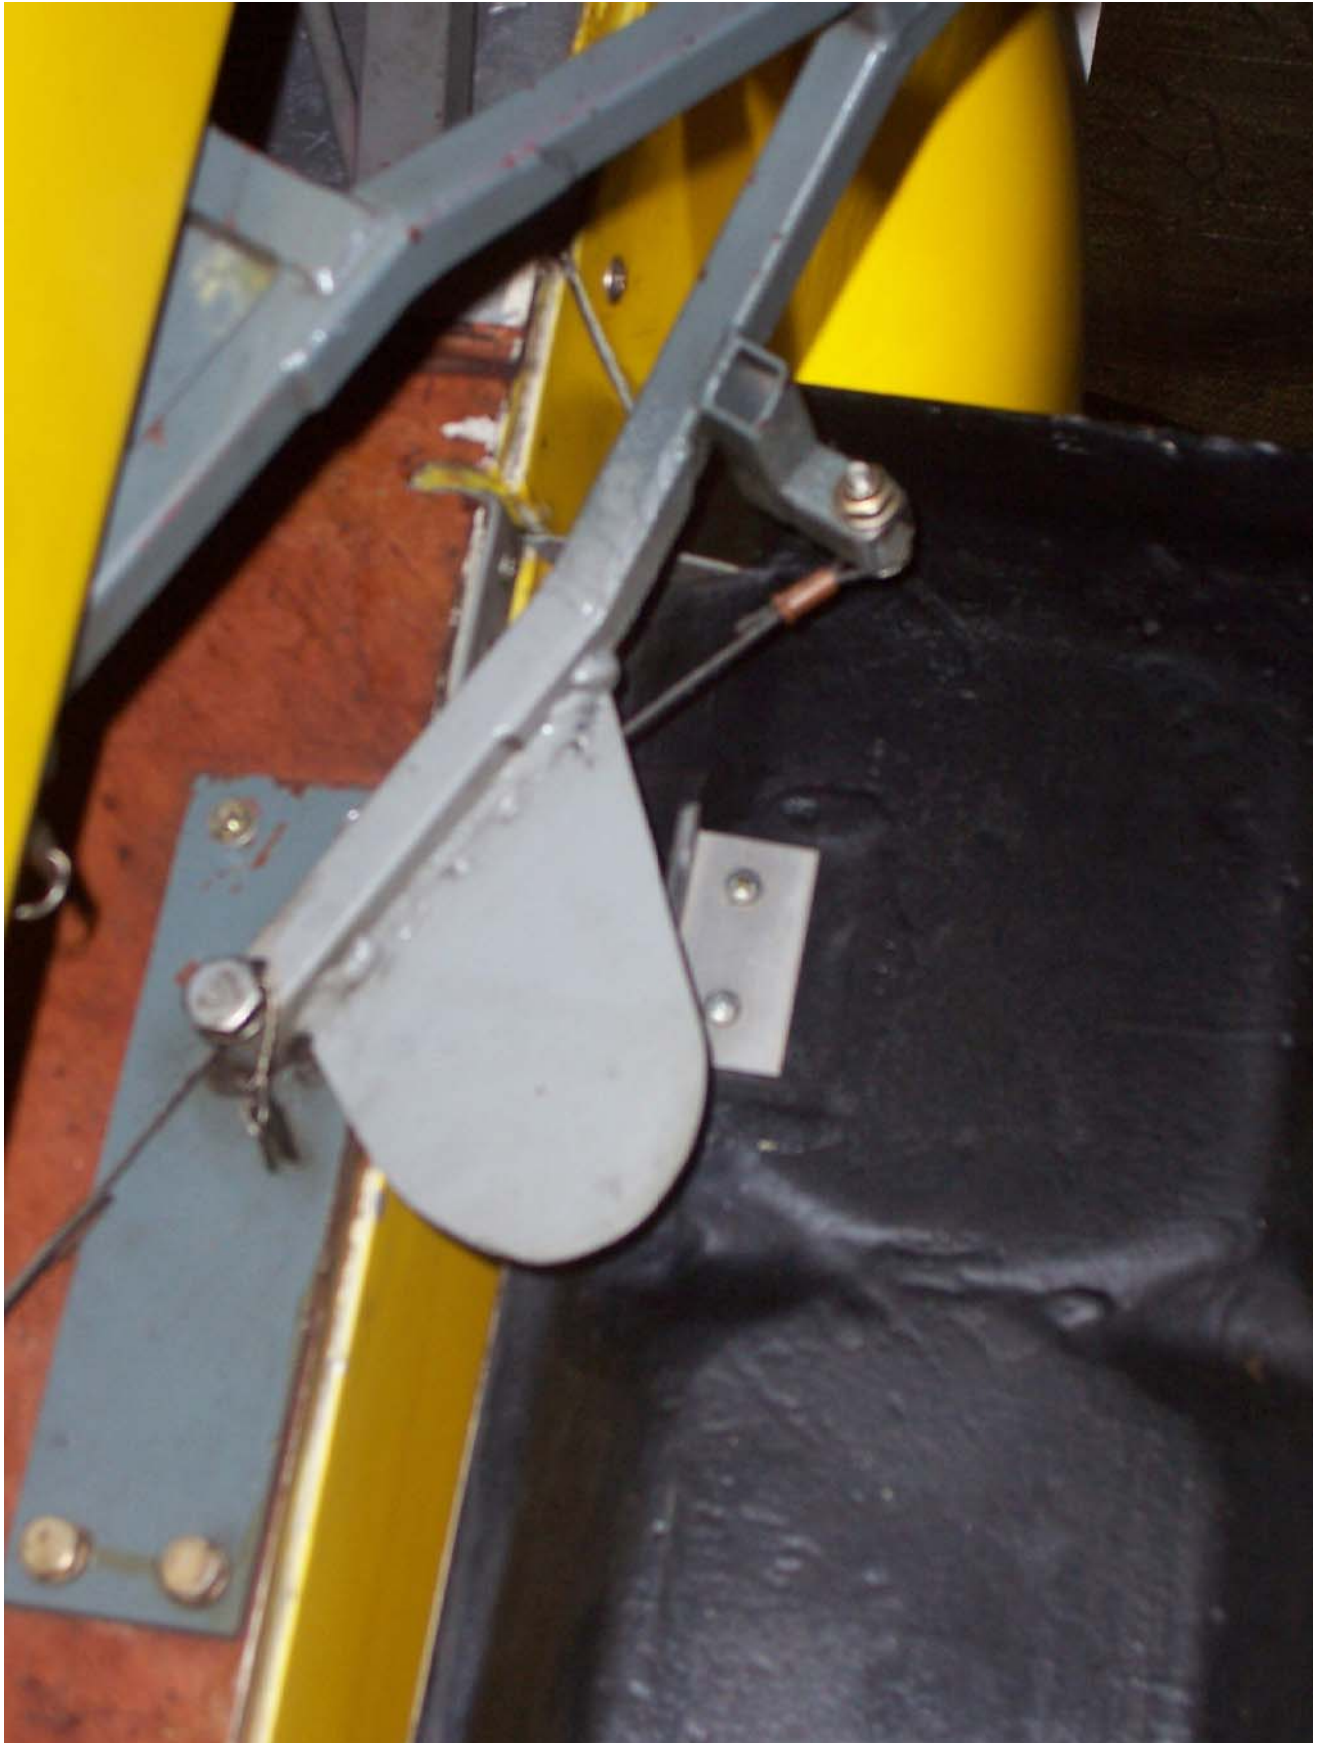
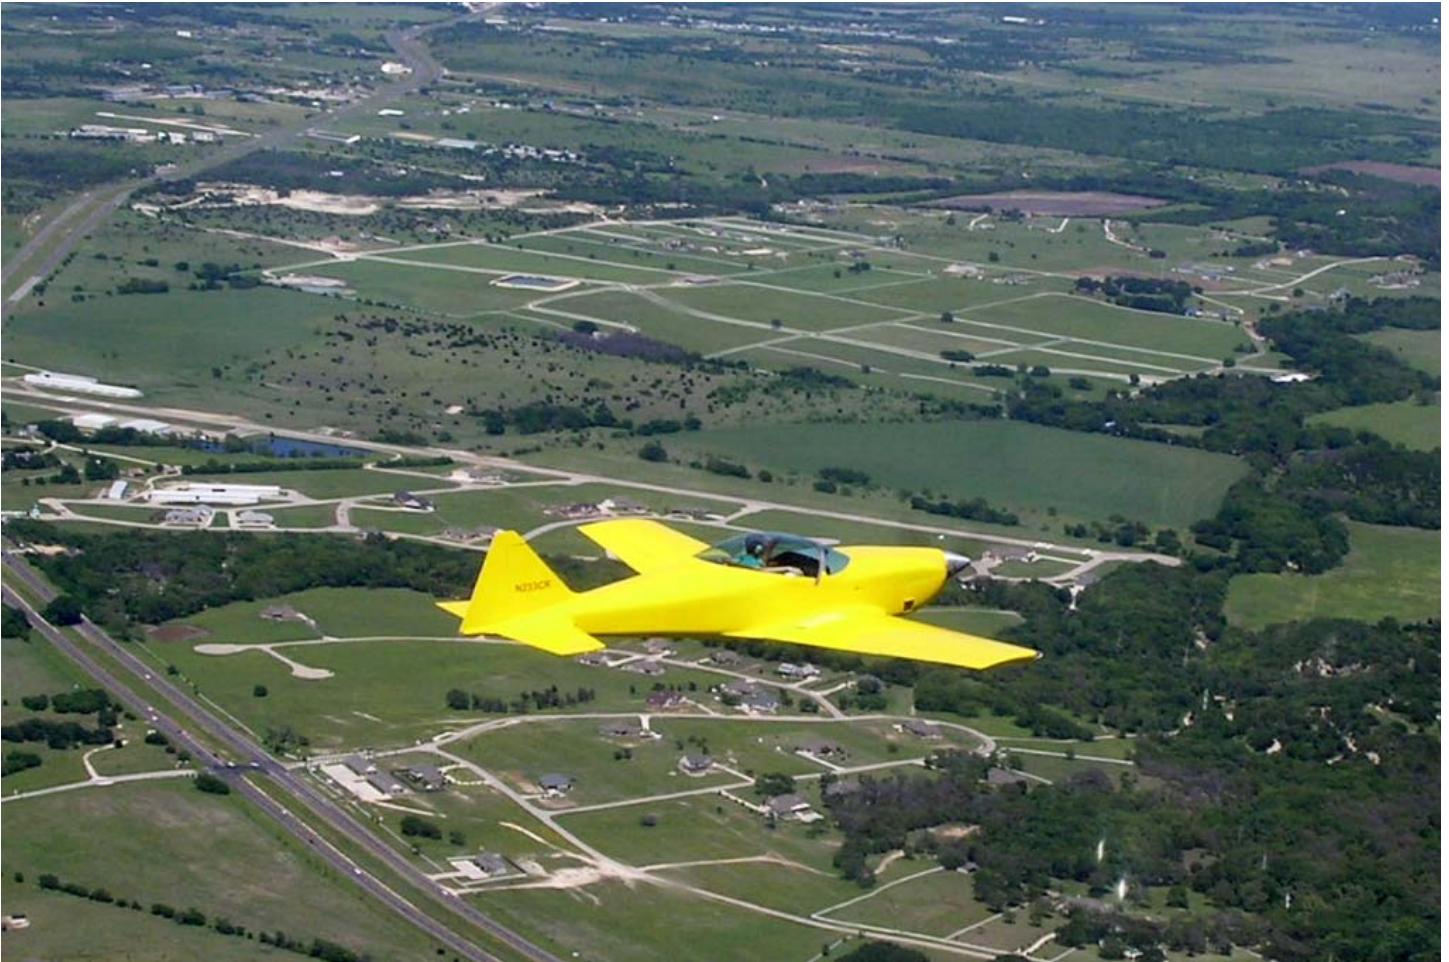
Anyone who has the manual retract system using the Johnson Bar and decides to use an air cylinder to close and open the long nose gear tunnel door will experience problems when you attempt to retract the landing gear.

The spring inside the cylinder is not strong enough to counteract the force of the airflow around the forward nose gear door which will blow the door inboard at an angle behind the nose gear. The nose gear strut will jam against the door when you attempt to retract the gear quickly. I filmed it from a chase plane and watched it happen. If the gear is retracted slowly, the forward door will clear long enough to allow the airflow to blow the long tunnel door out of the way, but this takes time and work.

The fix is simple and proven on two airplanes - mine and one other. Add an ear to the nose gear fork and an aluminum angle rub block to the nose gear door as shown in these photos. As for N233CR, I have completed the 25 hour test flight requirement and found no adverse flight characteristics. The airplane stalls clean at

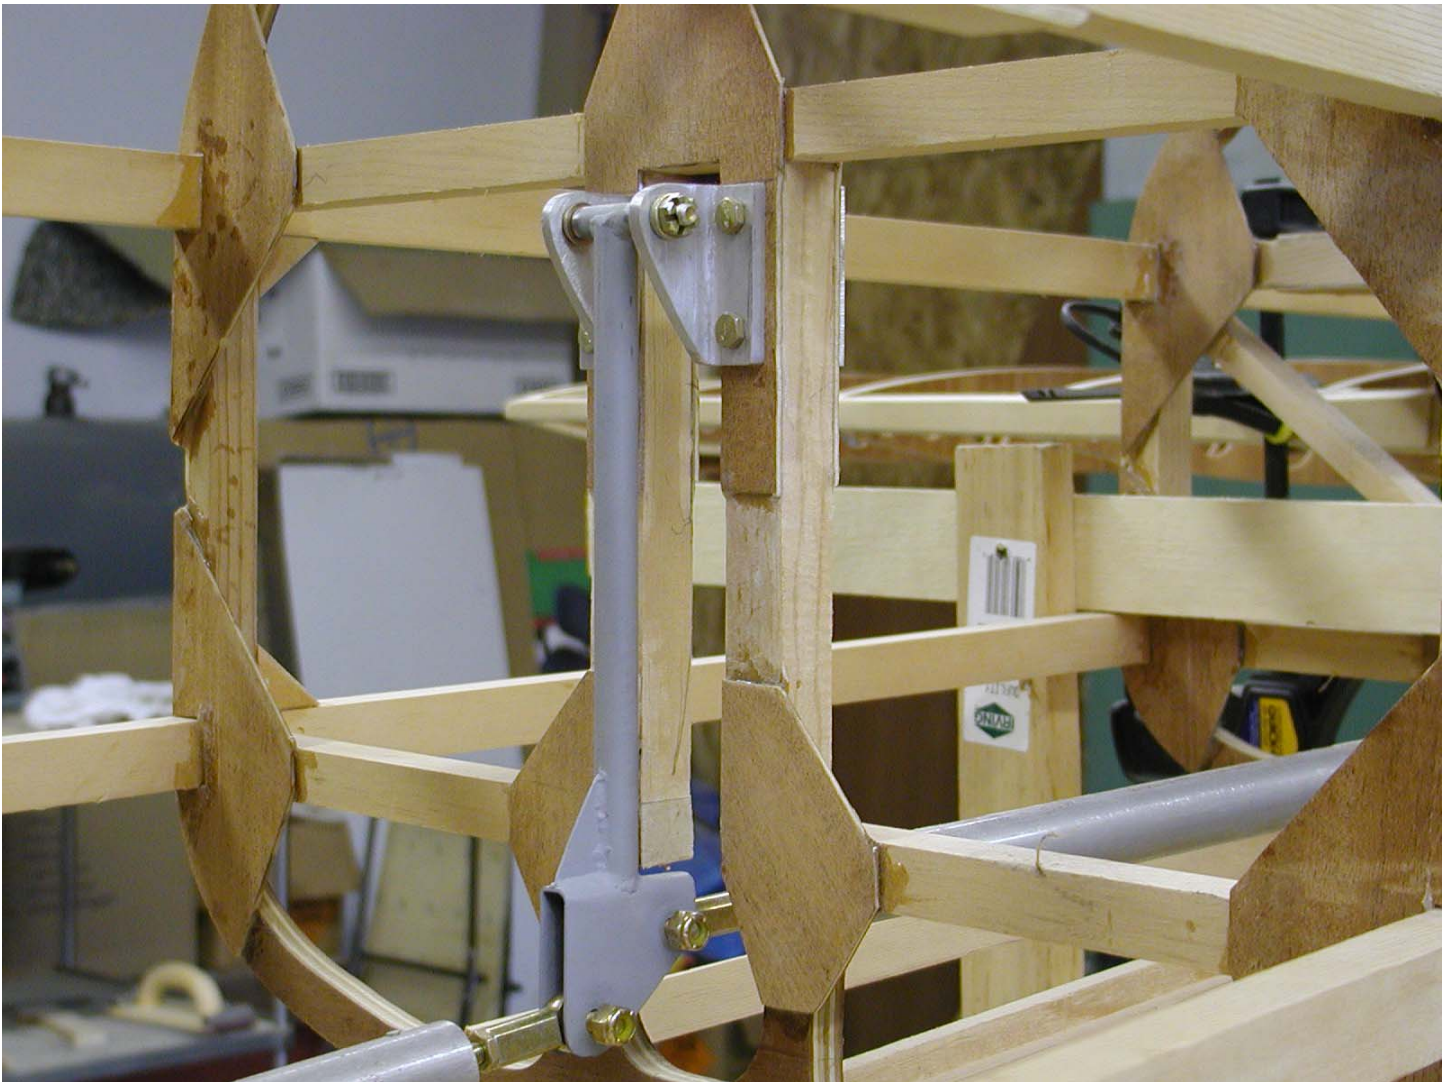
When installing the rear idler arm and clevis for the elevator push rod I found the rearward movement of the arm was hindered by the lateral lower cross member. Although it does not show on the plans it was

necessary to cut out the center of the cross member to allow the arm to swing rearward sufficiently to obtain full up deflection of the elevators. This area' due to its size is very sturdy but builders may wish

to install a cross brace on the rear of this Station in a position that would allow full travel of the elevators.
