**THE OFFICAL VOICE OF GP-4 BUILDERS ALL OVER THE WORLD**

VOLUME 2

MAY - JUNE 1995

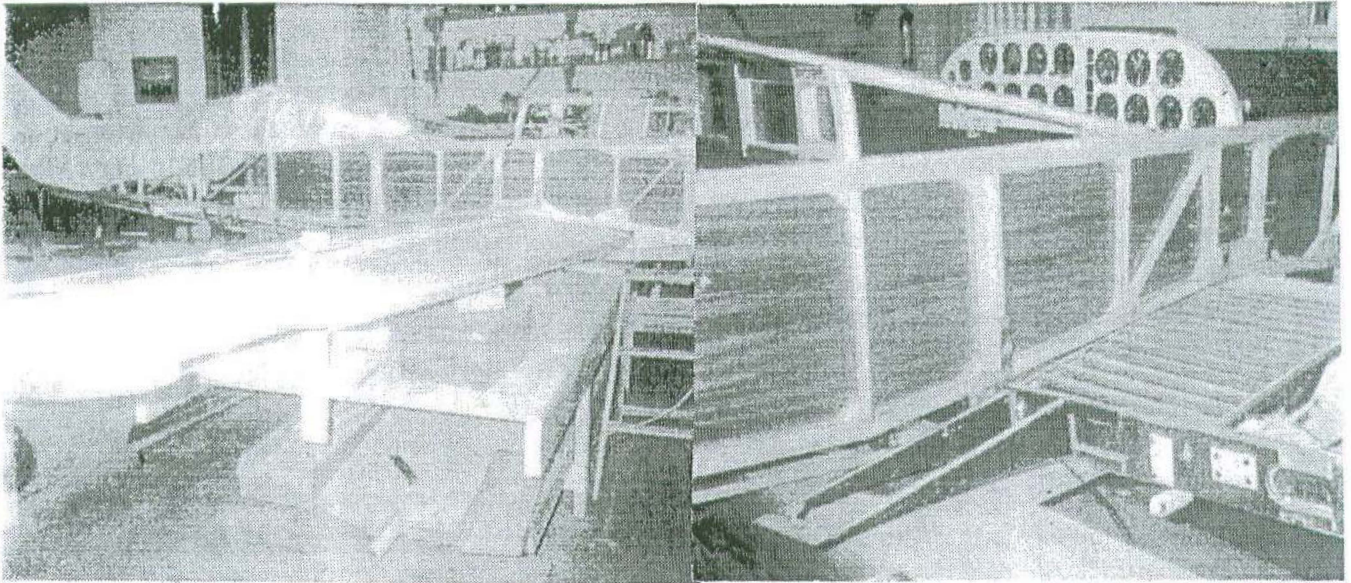
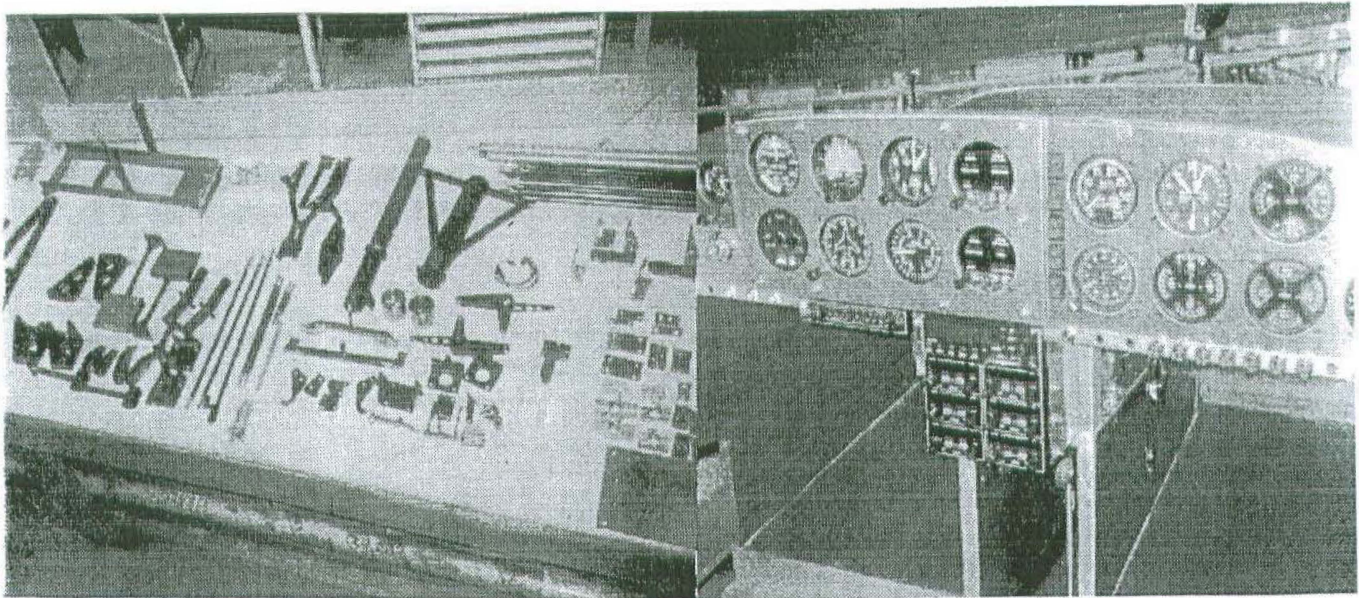
## BILL BERRICK OF OMAHA, NEBRASKA

Here are some photo's of Bill Berrick of Omaha, NE progress. Looks like he's moving hard and fast. Maybe we can count on Bill to supply us with some more details on his GP-4 in a future issue of GP4BFN. - SPUD
